SAMPLE
REPORT

Exterior Cladding Evaluation

Lunny Building Diagnostics

The subject property is a 25 year old single family home located in Furlong, PA. The home has a combination gable/hip style roof system with 3 tab asphalt shingles installed over the wood decking. The windows in the home are double hung wood and the exterior cladding system is hardcoat stucco.

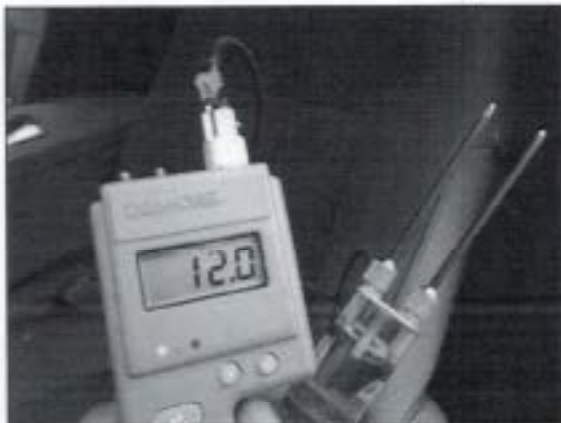
2.0 Item 1(Picture) The moisture probe used was calibrated prior to the test and after every second reading. Probe tips are Teflon coated and protected with shrink wrap to reduce the risk of outside interference.

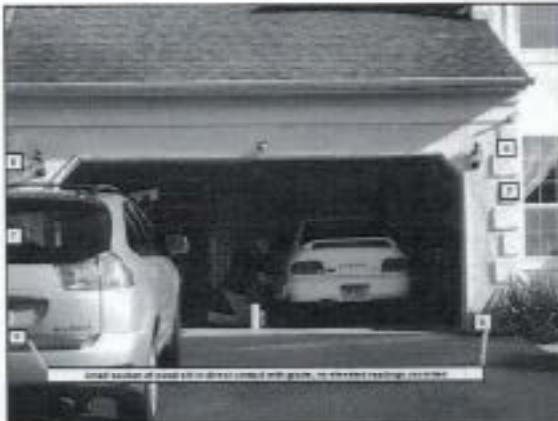
No elevated moisture readings were recorded on the front elevation.

2.1 Item 1(Picture) Front left Findings

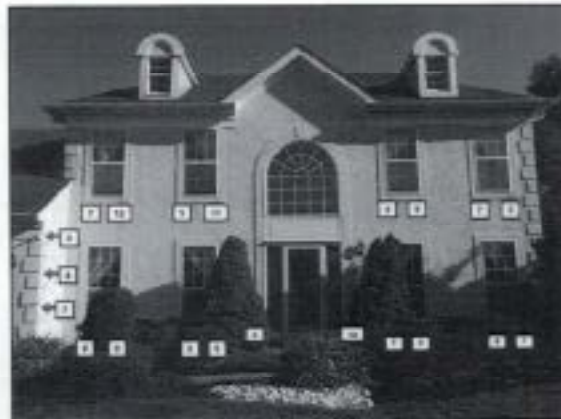
2.1 Item 2(Picture) Front right Findings

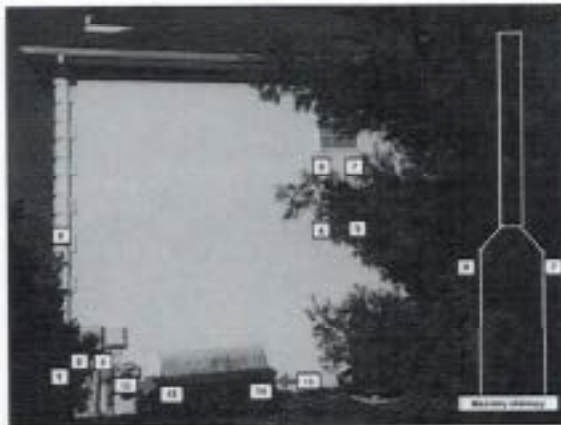
The right elevation did not record any elevated moisture readings at the time of the evaluation.

2.2 Item 1(Picture) Right elevation Findings

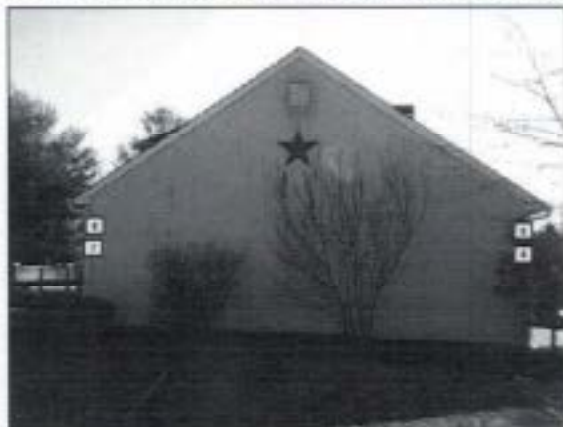
The left elevation was visually inspected & invasively tested, the left elevation did not record any elevated moisture readings at time of inspection.

2.3 Item 1(Picture) Left elevation Findings

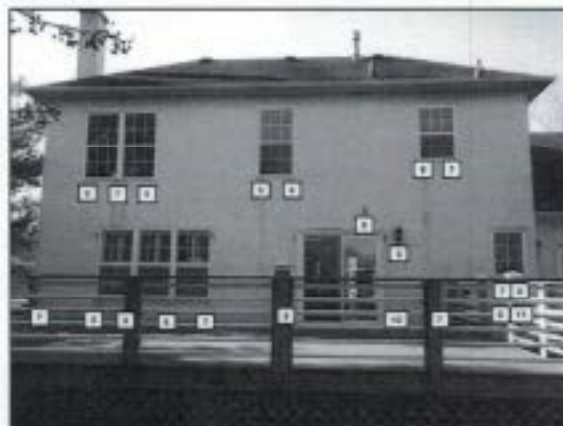
The rear elevation was visually inspected & invasively tested. No elevated moisture readings were recorded at the time of the evaluation.

2.4 Item 1(Picture) Left rear Findings

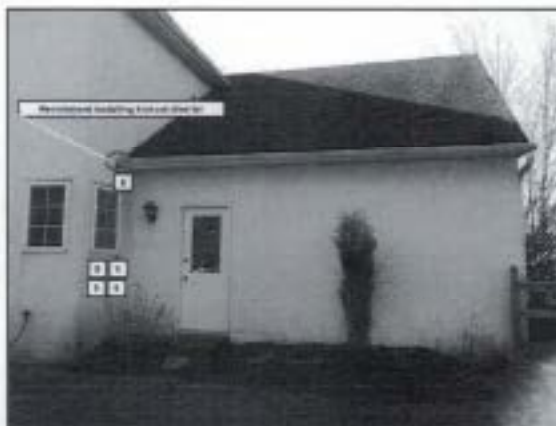
2.4 Item 2(Picture) Right rear Findings

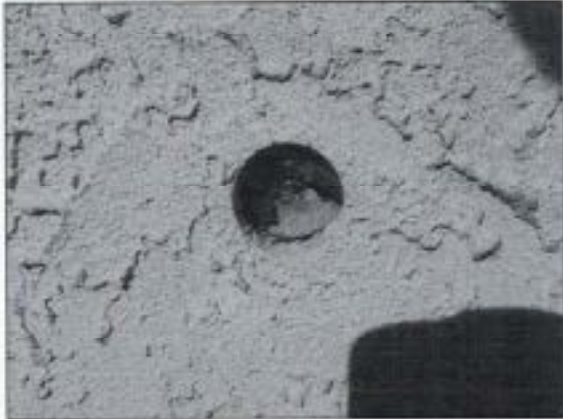
3.0 Item 1(Picture) Core sample confirms Thermo Ply Substrate & tar paper for the WRB

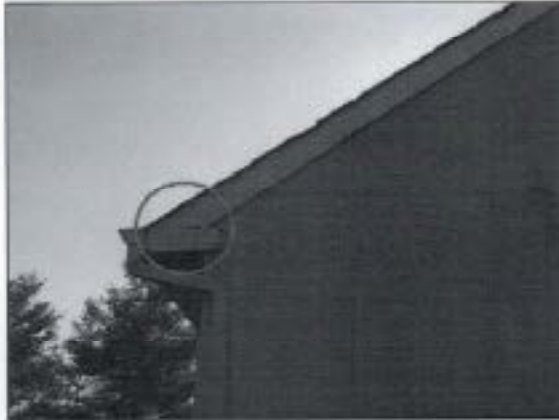
3.0 Item 2(Picture) Moisture damaged wood noted at roof returns on garage, repair as needed to reduce the risk of moisture penetration

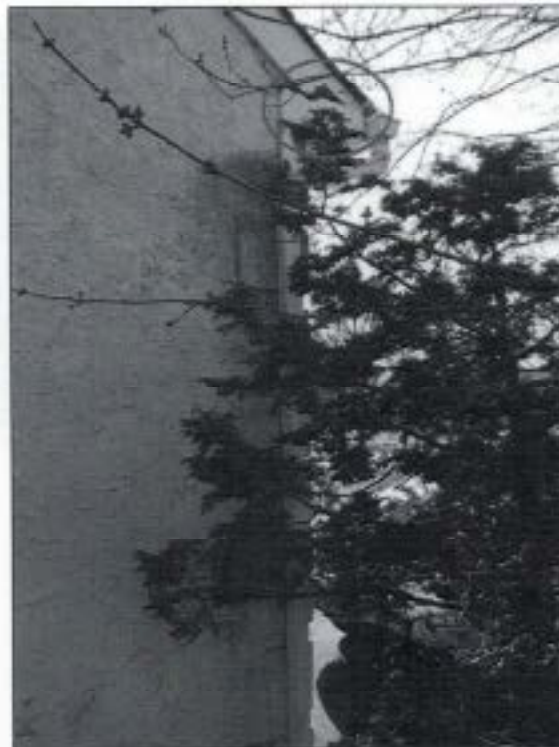
3.0 Item 4(Picture) Moisture damaged wood noted on garage roof returns, replace all moisture damaged wood to reduce the risk of moisture penetration

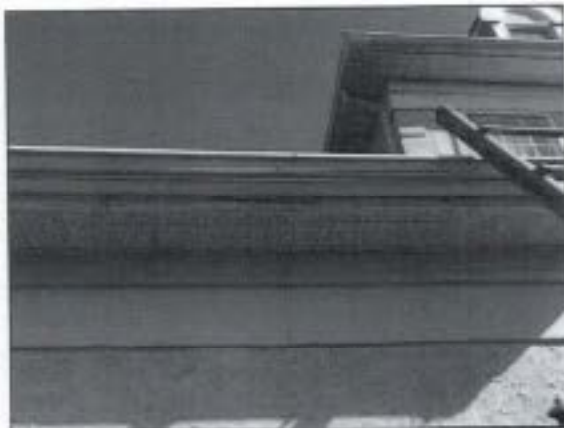
3.0 Item 5(Picture) Replace any moisture damaged wood on fascia

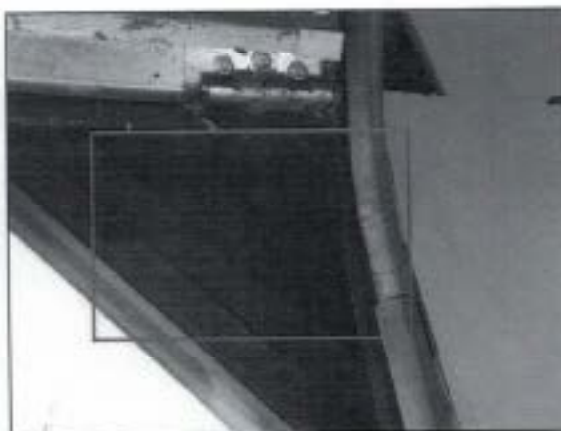
3.0 Item 6(Picture) Thermo Ply visible in garage

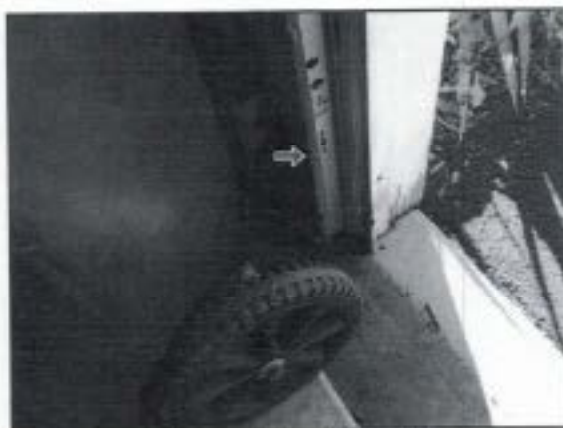
3.0 Item 7(Picture) Small sill plate at grade on left & right of garage doors

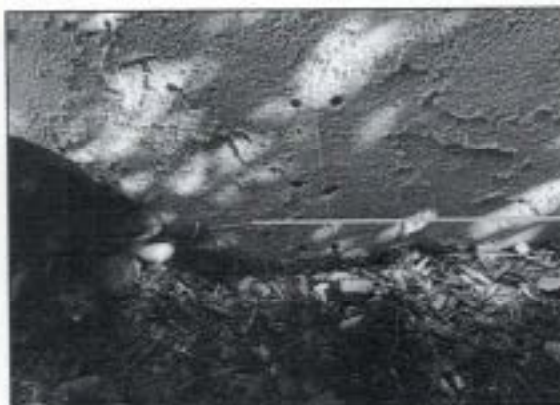
3.0 Item 8(Picture) Foundation wall is slightly above grade, no weep screed is installed, lowering grade to a minimum of 4" below top of foundation wall is recommended to reduce the wicking effects of water & insect activity

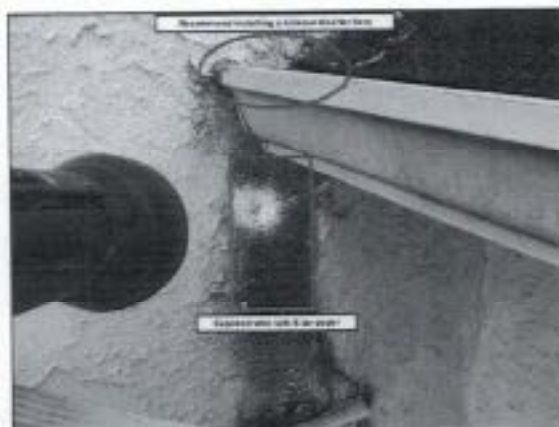
3.0 Item 10(Picture) Right rear, repairs & installation of kickout diverter recommended
