Stucco Woes: The Perfect Storm

By Joseph W. Lstiburek, Ph.D., P.Eng., Fellow ASHRAE

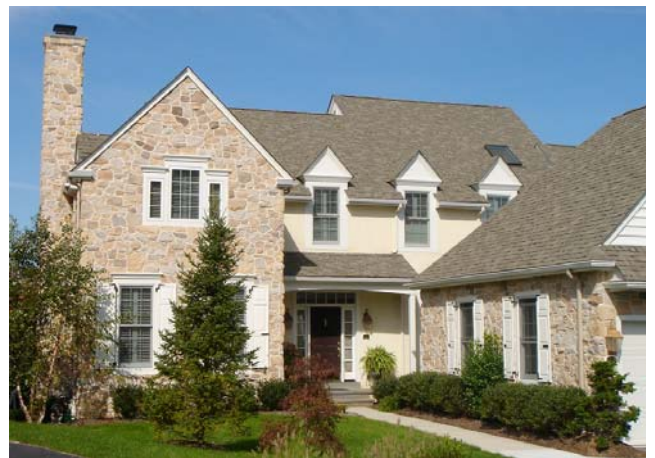
Photograph 1: Pennsylvania Stucco “Shack”—Eastern Pennsylvania is the stucco failure capital of the United States. Note the manufactured stone veneer—or “lumpy” stucco on the front façade.

We are seeing problems with stucco claddings in field of the wall—away from windows and “other architectural features.” And the buildings affected are not shacks (**Photograph 1**). And the problems are not limited to

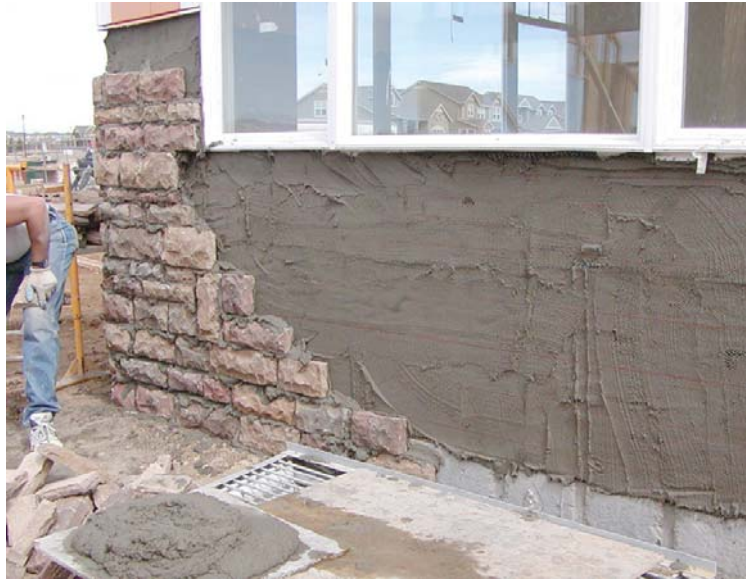
Photograph 3: Manufactured Stone Veneer—Manufactured stone veneer claddings are very similar to hardcoat stucco and perform in a similar manner. In a manufactured stone veneer the outer coat of stucco is replaced with a thin stone layer.

Hardcoat stucco is typically a three layer cementitious rendering (scratch coat, brown coat and top coat) applied over a building paper, metal lath and sheathing (**Photograph 2**). Manufactured stone veneer is a version of hardcoat stucco where the top coat is replaced with an embedded thin stone veneer (**Photograph 3**). Stucco claddings coupled with manufactured stone veneers are hugely popular because of their beauty—among other things. Unfortunately, the beauty is often only skin deep, as they are also commonly linked with moisture problems (**Photograph 4**). This was not always the case and the reasons for the change in performance are due to several seemingly small factors that add up to a huge factor:

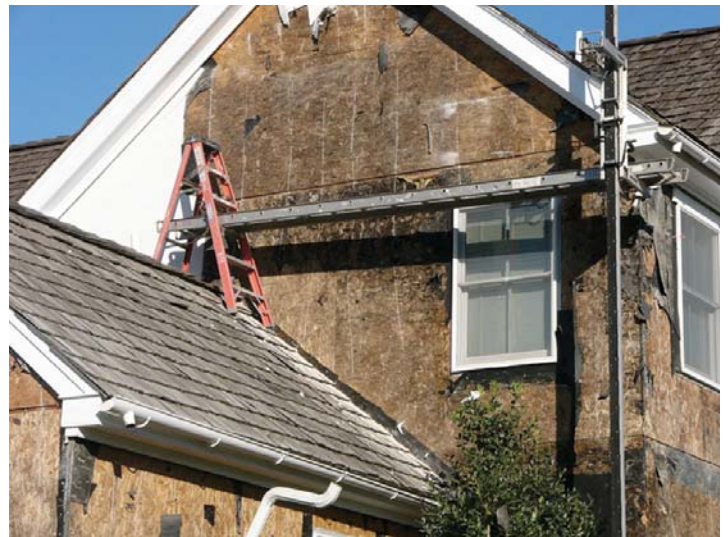
Photograph 4: Hardcoat Stucco Failures—Note that the damage is in the field of the wall away from windows.

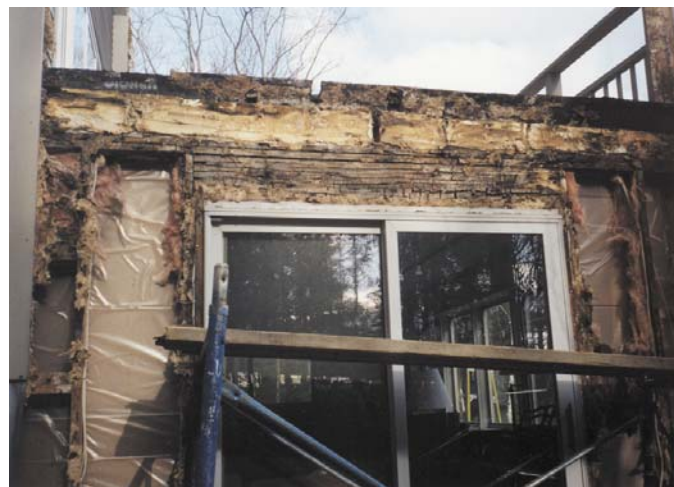
Photograph 5: Failure on Steroids—Note the plastic vapor barrier “accelerant” in this Vancouver, Canada building.

assemblies. In many cases even two of these changes combined do not lead to grief. But three, any three, and problems begin to raise their heads. And with four or all five, it gets ugly, very ugly—we call this type of ugly—Vancouver ugly (**Photograph 5**). Let's look at each of these small factors individually at first.

Now, to the plastic vapor barrier thing. What can I say that I haven't said about this earlier. The interior plastic vapor barrier prevents inward drying during cooling periods. Except in extreme heating climates plastic vapor barriers are unnecessary. The reduction of inward drying is often enough to push the wall over the edge if it is borderline to begin with (go back and look at **Photograph 5**).

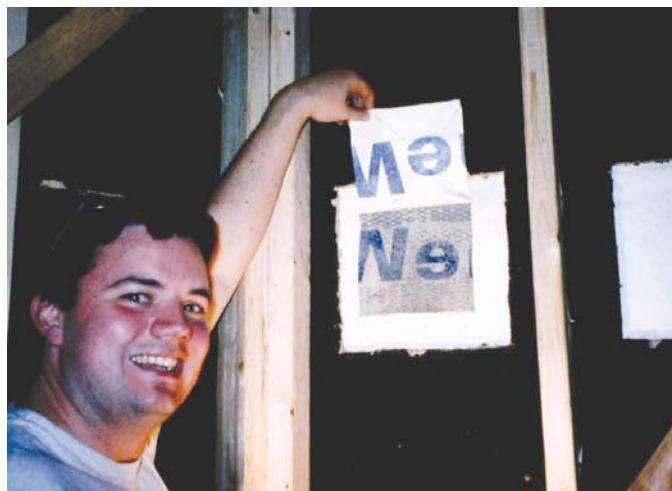
Photograph 6: Hardcoat Stucco Bonding to Plastic Building Paper—A young, happy engineer, discovers that stucco does indeed bond to plastic building papers preventing drainage. The engineer is my friend Chris Schumacher—may he remain this happy when he gets older.

Building paper manufacturing changes and the introduction of plastic building papers (also referred to as “building wraps” or “housewraps”) led to a change in the water management attributes of stucco renderings installed directly over these materials. Older building papers were more “robust” than more recently manufactured products—they weighed more and had more cellulose content. As a result when stuccos were applied directly over them a bond between the stucco and the building paper did not develop due to the dimensional instability of the cellulose. The absence of a bond permitted a modest degree of drainage to occur between the building paper and the stucco. With more recently manufactured building papers a bond develops between the building paper and the stucco—preventing drainage between the building paper and the stucco. The bond between plastic building papers and stucco is even greater (**Photograph 6**).

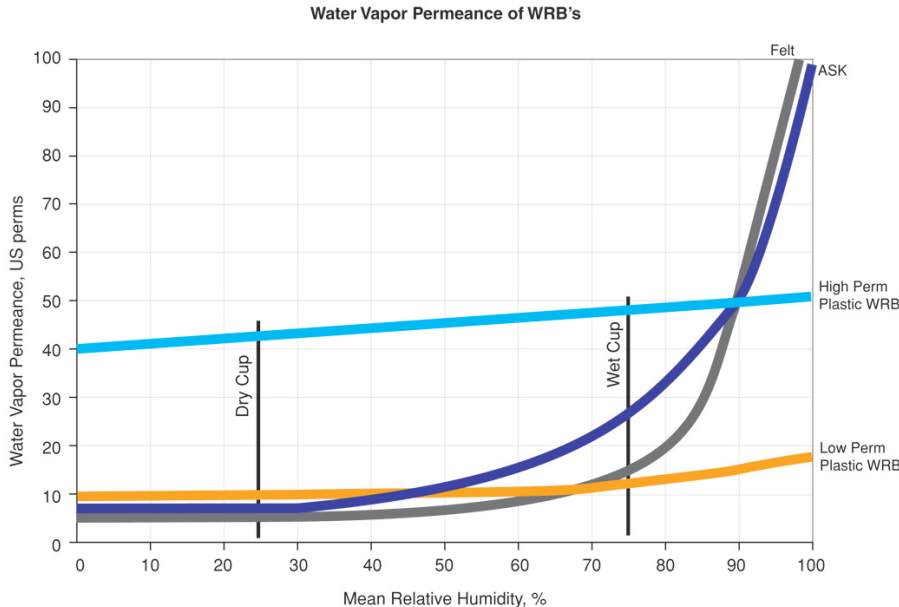
Figure 2: Permeance of Water Resistive Barriers (WRB's)—Debate rages within the building science community as to what the curves mean. The old guy in me intuitively believes that the shape of the curve describing the traditional building papers (WRB's) is “good.” And that the curve describing the “high perm” WRB is “not so good” and the curve describing the “low perm” WRB is “better but not as good as” the curve describing traditional building papers. I believe that if we could get a plastic building paper with a curve that mirrors the shape of the traditional building papers the product would “kick building science butt.”

Another attribute that changed was the water vapor transmission of the plastic building papers versus the traditional building papers (impregnated felts and asphalt saturated kraft paper) (**Figure 2**). What is the big deal with the shape of the curves? Well, it’s a “Goldilocks” thing—the materials should not be too vapor open or too vapor closed—but “just right.” With materials that are too vapor open—too much moisture stored/absorbed in the stucco layer can be driven inwards through the material under solar induced drive causing damage in the sheathing layer. With materials that are too vapor closed—not enough moisture will be able to exit the sheathing layer and dry outwards during drying events.
