## Stucco Homes & Real Estate Sales

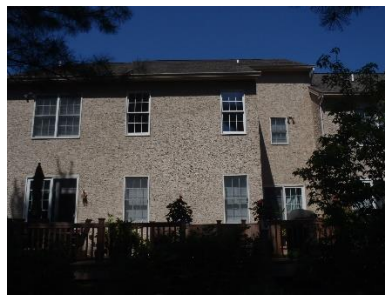
**Weep screed**

Below are examples of flashing details that help keep water from getting behind the stucco:
